Nevada Environmental Restoration Project

Rulison Site Groundwater Monitoring Report Third Quarter, 1996

February 1997

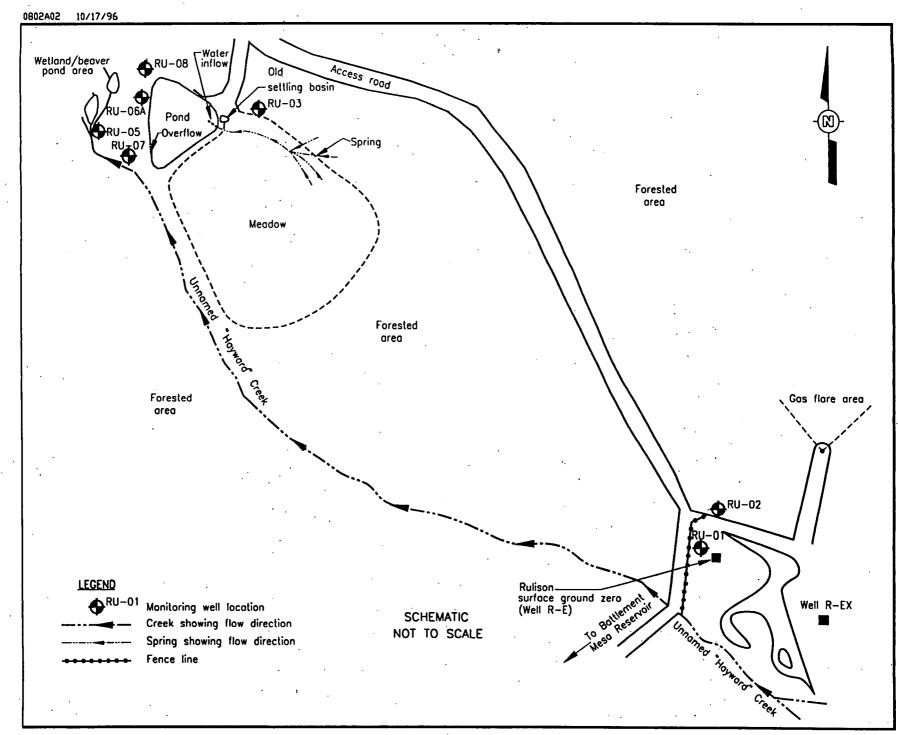
The drilling effluent pond is an engineered structure located approximately 400 m (1,312 ft) north-northwest of the surface ground zero (SGZ) emplacement well (R-E) (Figure 1-2). The pond covers approximately 0.5 hectare (1.2 acre) as measured at the top of the berm; it is triangular in shape; and it is approximately 6 m (20 ft) deep from the top of the berm to the pond bottom. The drilling effluent pond was used to store nonradioactive drilling fluids generated during drilling of the device emplacement well R-E. The drilling fluids consisted of bentonite drilling mud that contained various additives, such as diesel fuel and chrome lignosulfonate, used to improve drilling characteristics. Most of the drilling wastes were removed from the pond when the site was cleaned up and decommissioned in 1976; however, some drilling fluid was left in the pond. At the request of the property owner, the pond structure was left in place following completion of site decommissioning and was subsequently converted by the property owner to a freshwater holding pond containing aquatic vegetation, amphibians, and stocked rainbow trout.
